PERIODIC REVIEW

**Hilton Hotel Parking Garage
Facility Site ID#: 56642815**

**1305 6th Avenue,
Seattle, Washington**

TOXICS CLEANUP PROGRAM

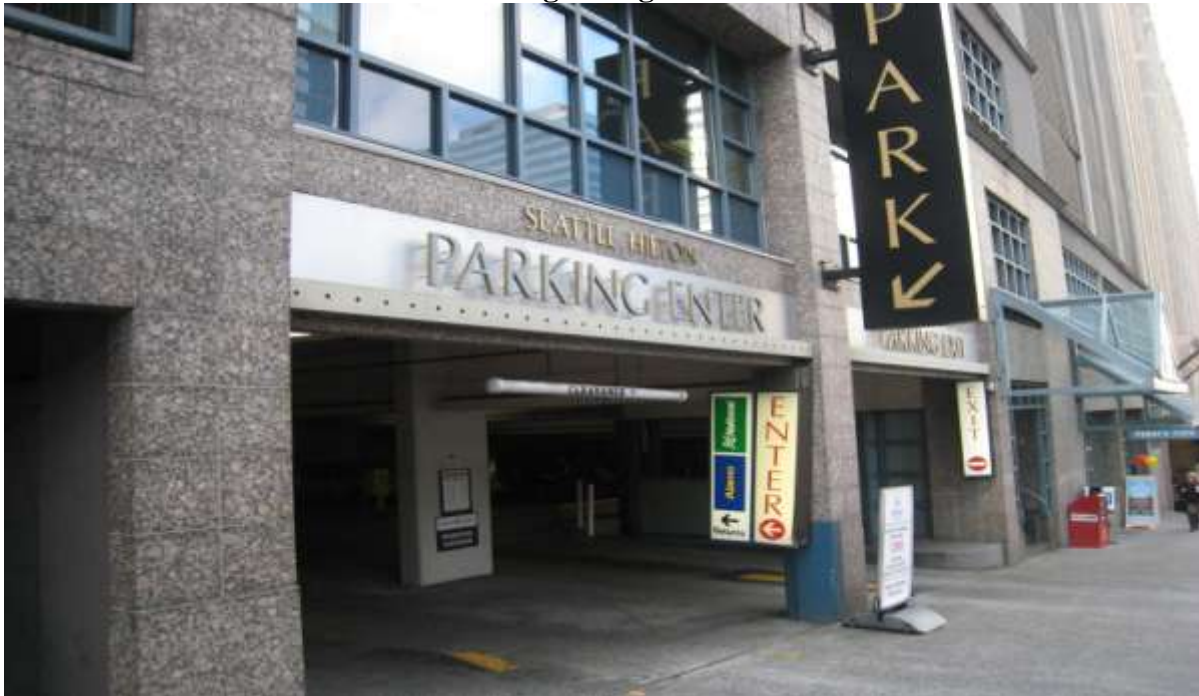
Photo 1: Entrance to Hilton Hotel Parking Garage – off of 6th from the southeast

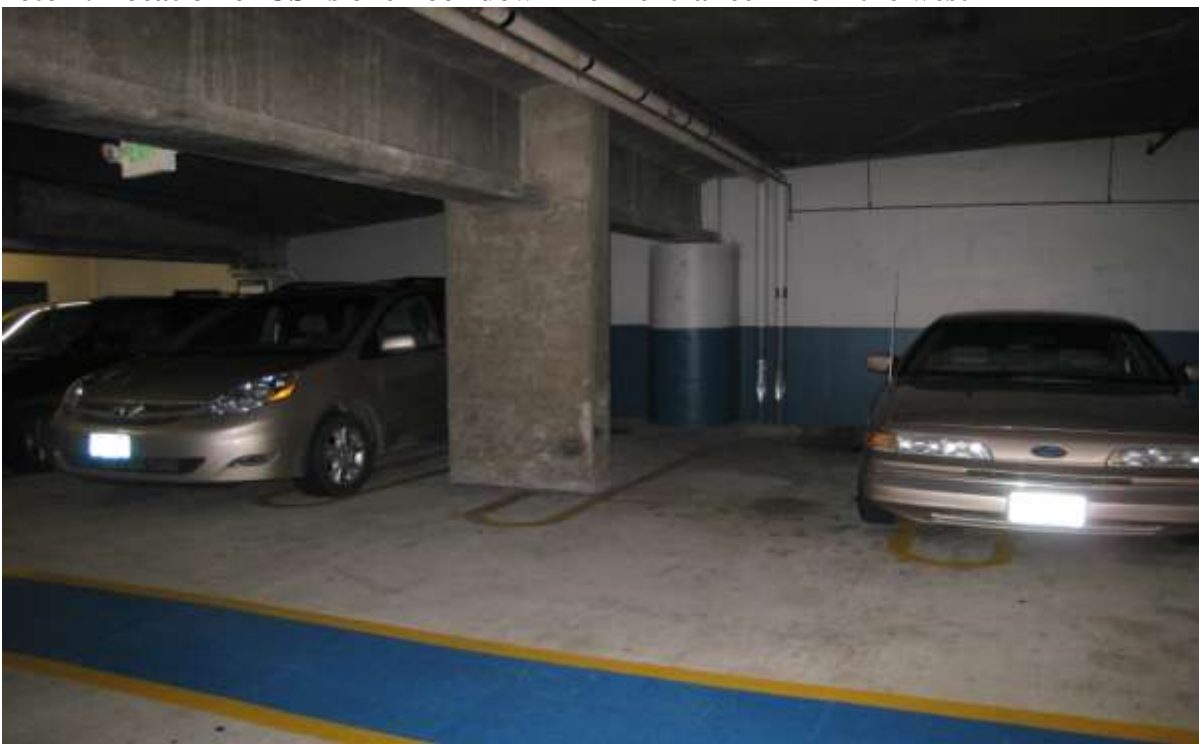
Photo 2: Location of USTs one floor down from entrance - from the west

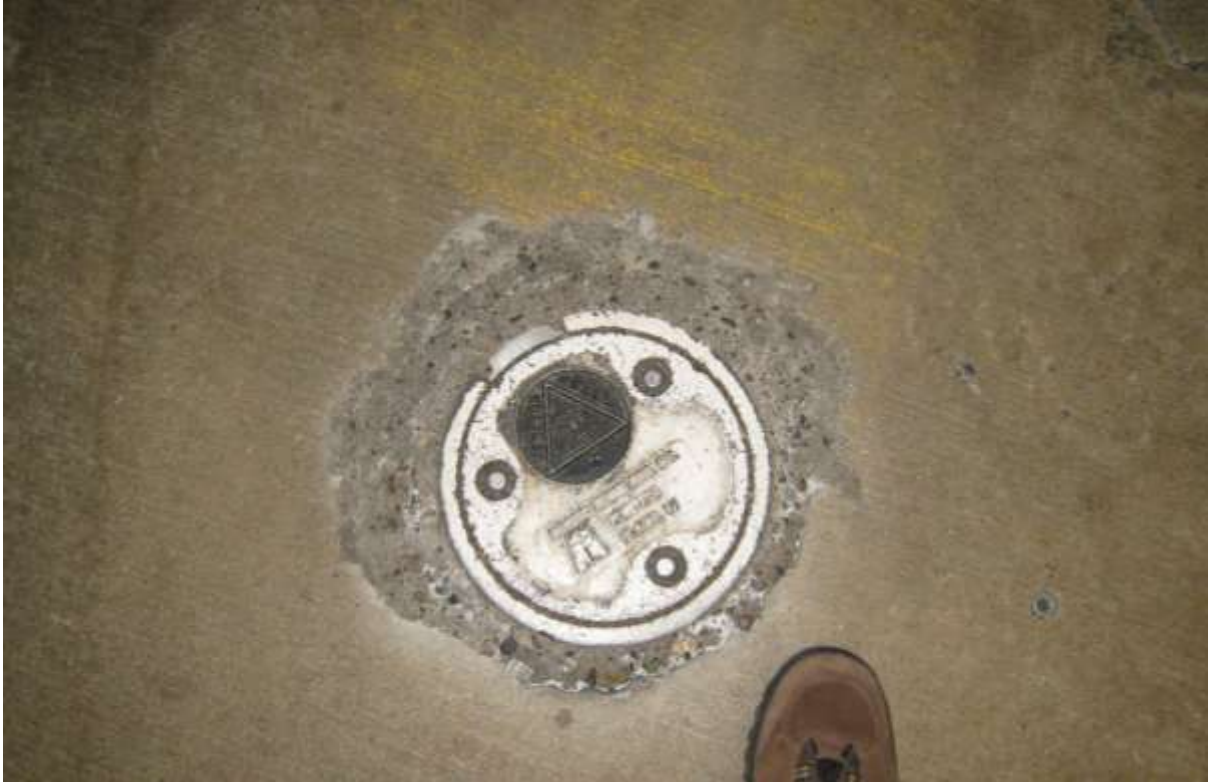
Photo 3: Monitoring Wells are still present – MW-2 and 3 near USTs, MW-4 a floor below

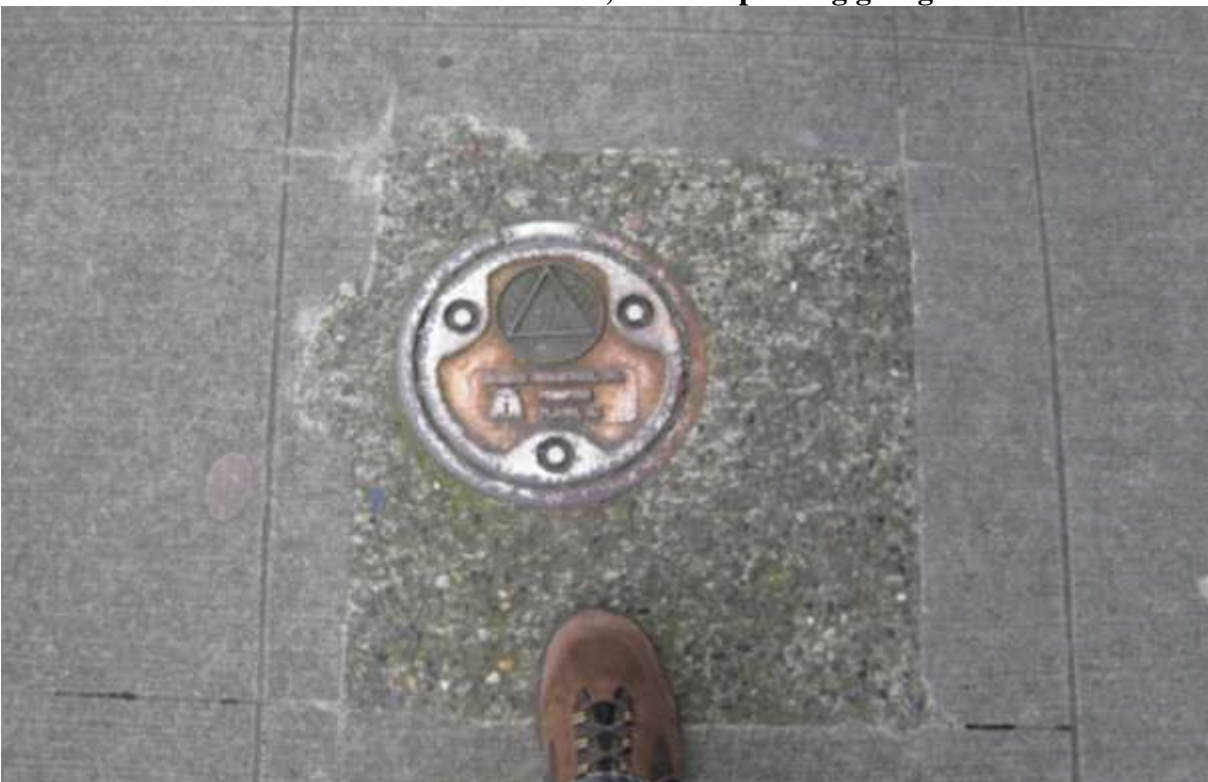
Photo 4: MW-5 is in the sidewalk – west of 6th, south of parking garage entrance
